VEGETATIVE DELINEATION REPORT

GIWW TO CLOVELLY WETLAND

Delineation date:	November 9, 1992
Report completion date:	November 1, 1993

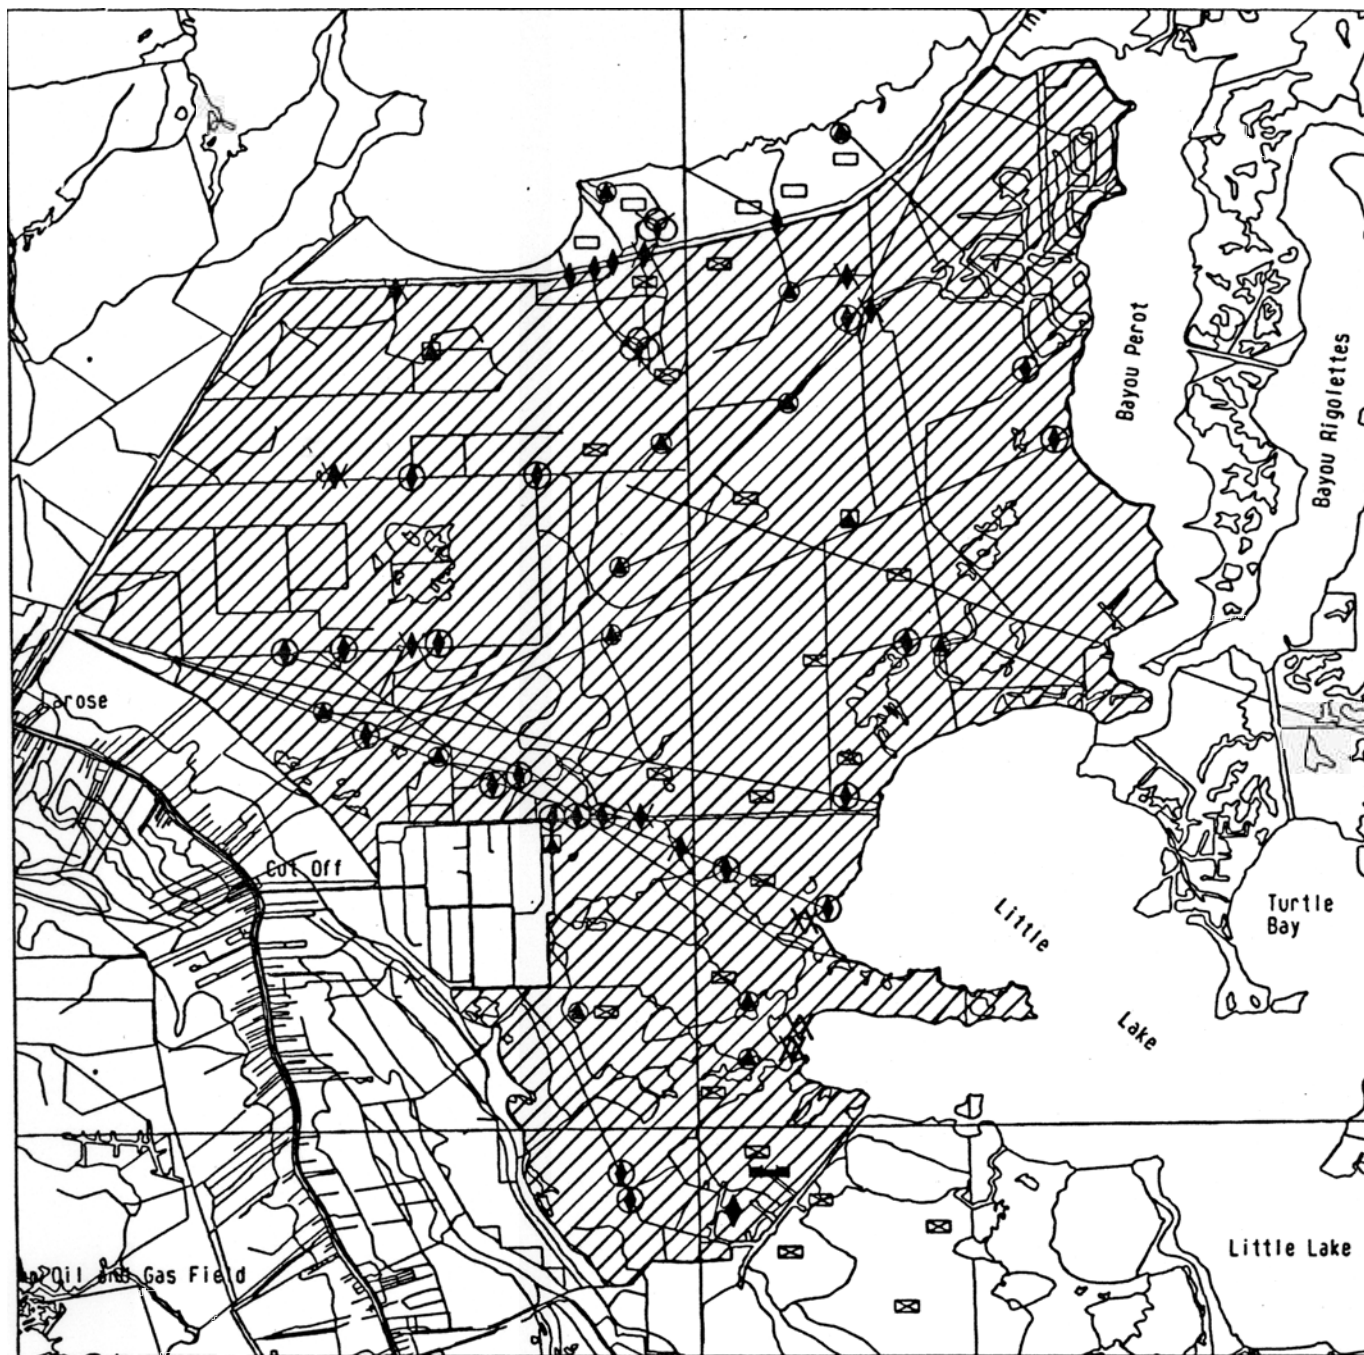
BA-2 Gulf Intercoastal Waterway to Clovelly Wetland Restoration

Seventeen vegetative stations were established throughout the project area (Figure 2). These stations were located in areas where transition from one vegetative zone to another could be detected. Stations were established along natural waterways in the southern portion of the area to provide long term data for any changes that may occur due to continued salinity encroachment.

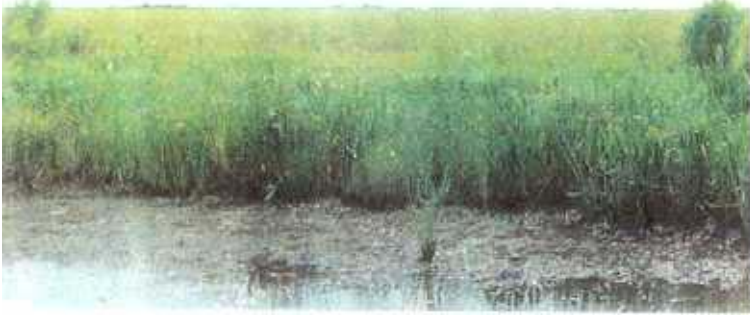
Figure 4

4.	Station 2 is located north of a Exxon pipeline along a ditch running north. This is a brackish marsh with 85% marshhay cordgrass, 10% bulltongue and 5% three-cornered grass. Photo is to the north . . .

Station 2 is located along a small ditch running north off of an east-west Exxon pipeline and is approximately at the point where Chabreck and Linscombe established the brackish/intermediate marsh boundary in 1988. The marsh was composed of marshhay cordgrass 85%, three-cornered grass 5%, and bulltongue 10%. This area is drained each time the tide is low in Little Lake and hunters/trappers have attempted to control the water levels with a small wooden bulkhead which has failed. Water salinity was 1 ppt and temp. was 22 C.

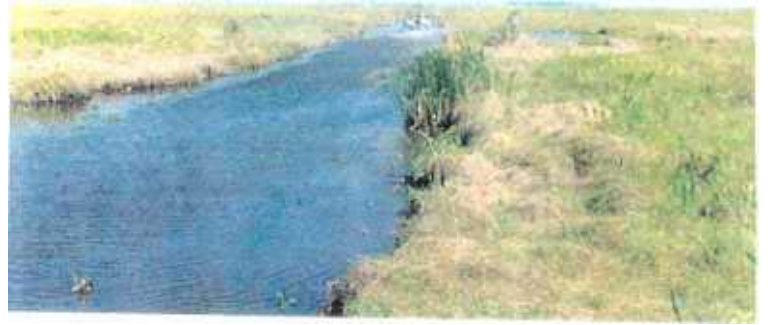
5.	Station 2 in within 1000 feet of the shoreline of Little Lake. Photo is to the east	
6.	There was extensive evidence of nutria feeding at station 2. Photo is to the west

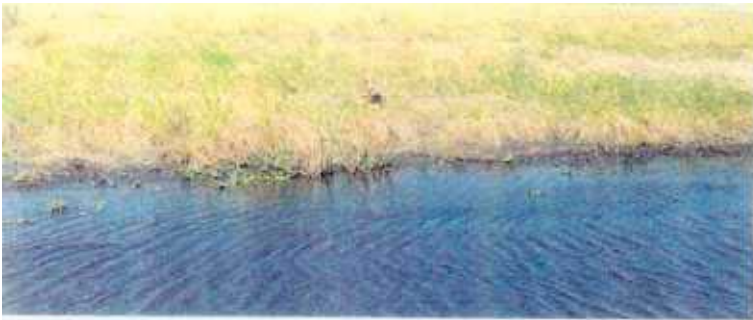
Figure 7

7.	Station 3 is on the south side of an interior lake in a brackish marsh with 90% marshhay cordgrass, 5% three-cornered grass and 5% bulltongue. Photo is to the southwest

Station 3 is located alongside of a trapping access ditch just west of the north-south electrical powerline. The salinity was 0.5 ppt. The marsh is intermediate in this area with marshhay cordgrass 80%, three-cornered grass 5%, cattail (*Typha* spp.) 5%, and bulltongue 5%. Small clumps of sawgrass (*Cladium jamaicense*) and broomsedge (*Andropogon glomeratus*) was noted in this section of the marsh. Nutria feeding activity was very common in the marsh and along the edge of the trapping ditch. Past burning activity in this section of the marsh had produced excellent stands of vegetation.

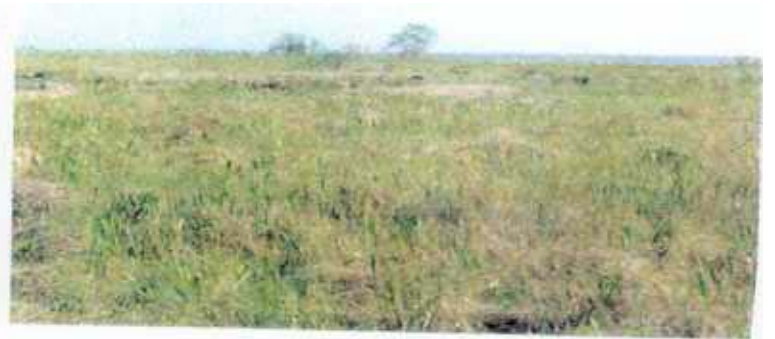
Figure 8

8.	Extensive drift deposits from Hurricane Andrew was noted at station 3. Photo is to the east	
9.	Clumps of marshhay cordgrass had been washed into the large pond at station 3. Photo is to the northwest

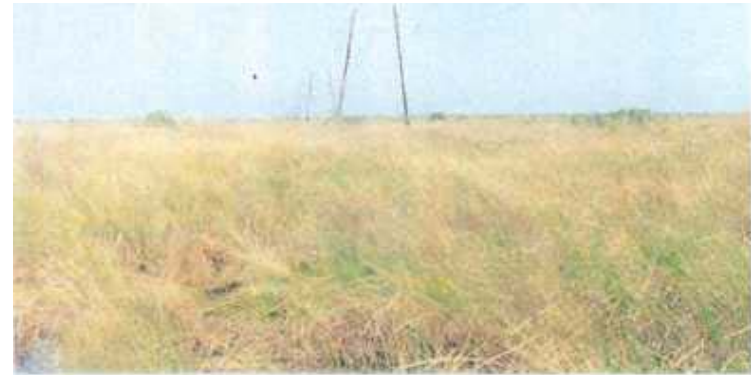
Figure 12

12.	The marsh at station 4 is brackish with 80% marshhay cordgrass, 10% three-cornered grass, 5% bulltongue and 5% cattail. Photo is to the northeast

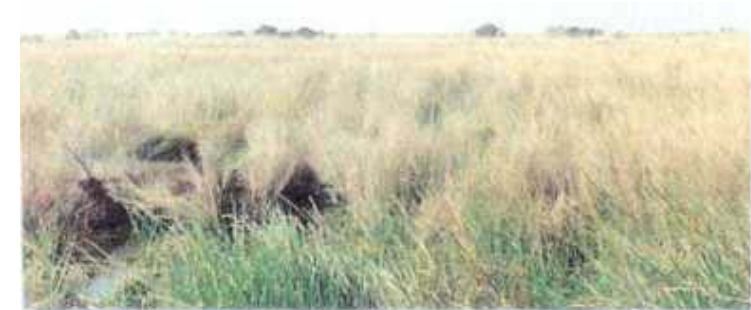
Figure 14

13. Baccharis and cattail clumps were scattered in the marsh at station 4. Photo is to the southwest
- Station 5 is located where the interior ditch crosses an old interior bayou that is now a floating marsh. Photo is to the east

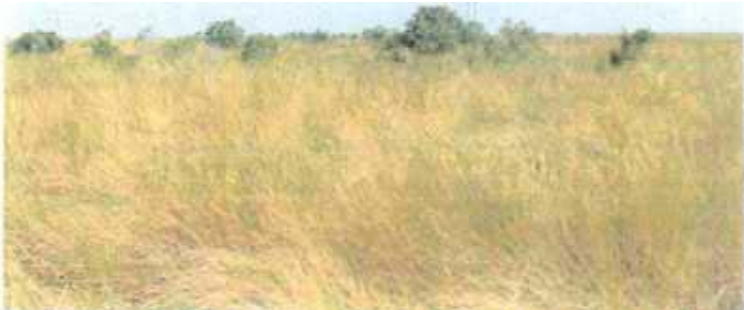
Figure 15

- Marshhay cordgrass was 70% at station 5 with bulltongue 20%, and a mixture of three-cornered grass and large spikerush 10%. Photo is to the southeast

Station 5 is located at a point where the trapping ditch crosses an old bayou system that has filled with floating marsh. Waxmyrtle (*Myrica cerifera*) was common along the submerged bayou banks and on floating mats of vegetation. The marsh at this station was composed of marshhay cordgrass 70%, bulltongue 20%, and the remaining 10% was a mixture of three-cornered grass, alligatorweed (*Alternanthera philoxeroides*), spike rush (*Eleocharis parvula*) and (*Eleocharis* spp.), sedge (*Carex* spp.), smartweed (*Polygonum* spp.), and waterhyssop (*Bacopa monnieri*). The trapping ditch and other open water sites in this area had a dense growth of duckweed (*Lemna minor*) and common salvinia (*Salvinia rotundifolia*). Salinity of the marsh water throughout this portion of the project area was 0.5 and did not vary.

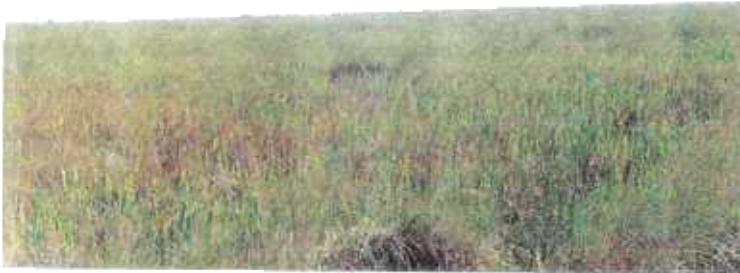
Figure 16

16. Wax myrtle is growing on the floats in the old bayou system at station 5. Photo is to the west
17. Station 6 is located approximately half way between a large interior pond and an mineral access canal. The marsh is fresh to intermediate at this site. Photo is to the north

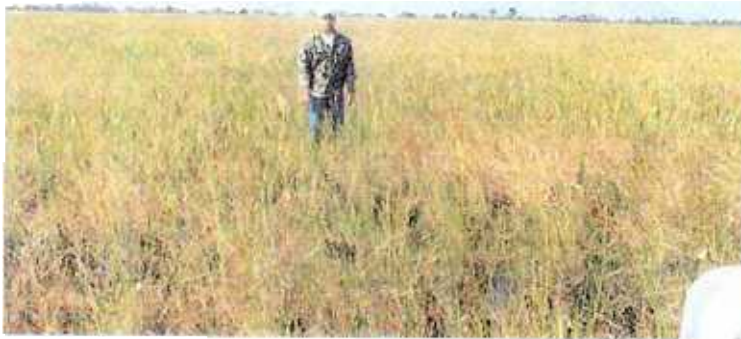
Figure 18

18. The marsh at station 6 was 85% bulltongue, smartweed 10%, and 5% maidencane. A species of large spikerush was mixed throughout the vegetation. Photo is to the east

Station 6 is north of a large shallow pond on the north side of the old bayou system. The marsh is fresh at this site and is composed of 85% bulltongue, 10% smartweed, and 5% maidencane (*Panicum hemitomon*). The marsh is a floating mat of vegetation and is very healthy. The marsh surface water supports stands of salvinia, waterhyssop, and spike rush.

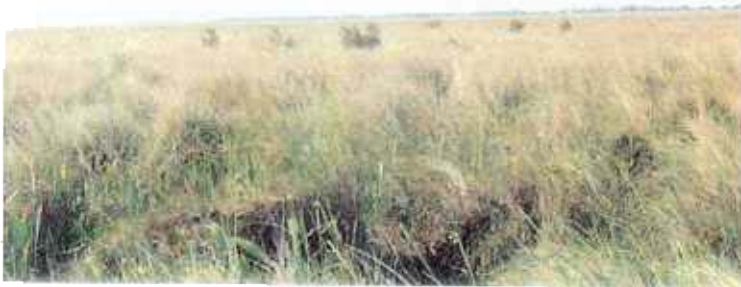
Figure 20

20. A clump of trees are located in the marsh near station 7 and may be an Indian midden. Photo is to the north
21. Station 8 is located at the point where the powerline crosses a long canal that runs northeast-southwest. This is a fresh marsh that is going to intermediate. Marshhay cordgrass was 50%, bulltongue 30%, maidencane 10%, and a mixture of cattail, smartweed, bullwhip and spikerush throughout the area. Photo is to the south

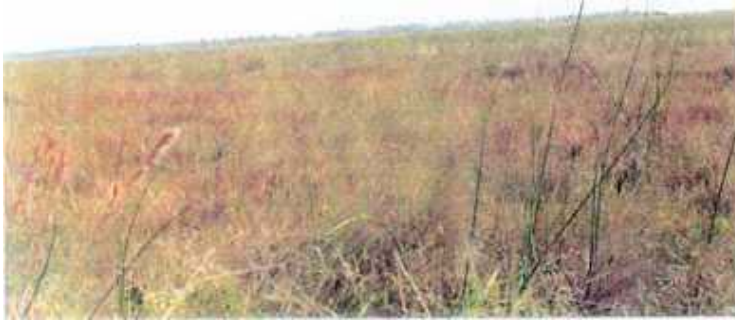
Figure 22

22. Marshhay cordgrass is invading the area at station 8. There was lots of white-tailed deer sign on the levee system. Photo is to the northeast
23. Station 9 is along an interior ditch near the southwest end of a mineral access canal. This is a fresh marsh with 90% maidencane. Photo is to the east along the ditch system

Station 8 is located on the south side of the pipeline canal leading northeast towards Bayou Perot. The marsh in this area is fresh but appears to be going to intermediate. Plants at this station were 50% marshhay cordgrass, 30% bulltongue, 10% maidencane, and 10% cattail. There was a dense stand of smartweed as an understory in this area except within the marshhay cordgrass stands. There were sprigs of bullwhip (*Scirpus californicus*) and sawgrass in this marsh. There was an extensive amount of white-tailed deer sign on the spoil banks in the form of tracks and droppings.

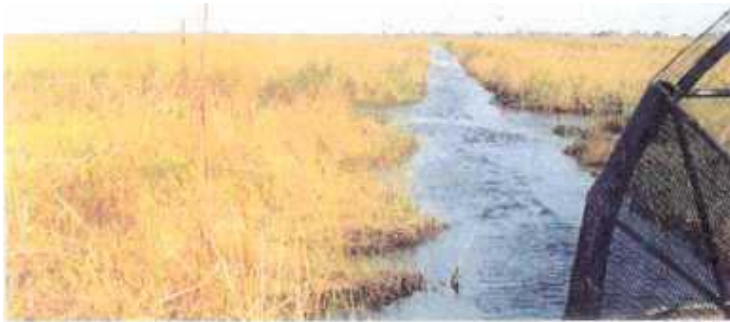
Figure 24

Photo is to the southwest from station 9 and is across the maidencane marsh

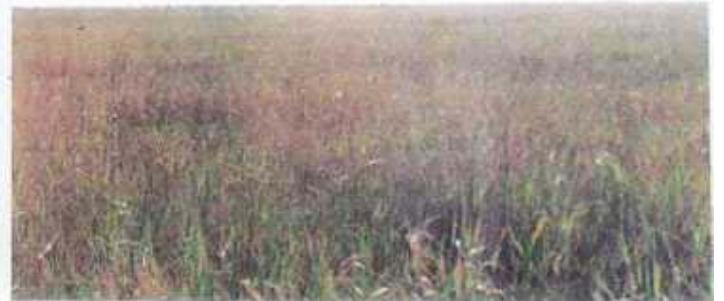
Figure 25

25. Station 10 is located on the west side of the east levee around Delta Farms. This is a fresh marsh. Photo is to the west

Station 10 is located on the east side of the Delta Farms reclamation area. Marsh on the west side of the levee system is composed of 50% cutgrass (*Zizaniopsis miliacea*), bulltongue 40%, maidencane 10% with a mixture of plumegrass and cattail. Large live oaks and hackberry trees are growing on the levee system. The open water portion of the Delta Farms ponds supports a dense stand of southern naiad and coontail. Most of the large canals in this section of the marsh are covered with a growth of water hyacinth.

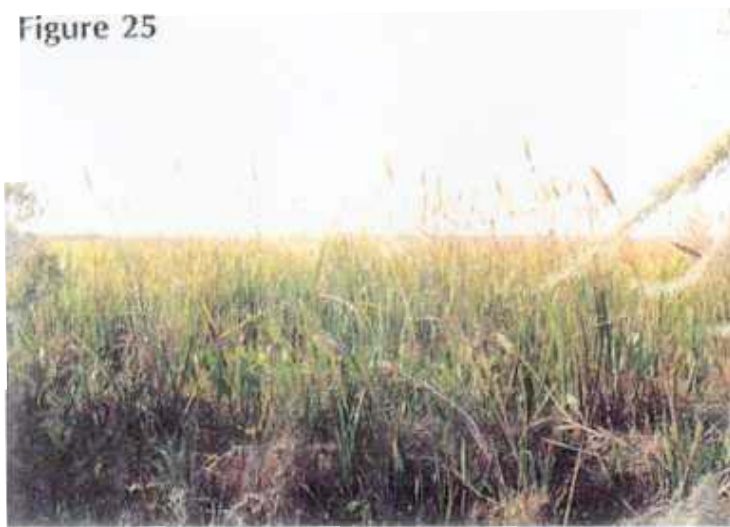
Figure 26

26. The levee at station 10 supports a good stand of woody vegetation. Photo is to the northwest
